The Local Oscillator

The Newsletter of Crawford Broadcasting Company Corporate Engineering

OCTOBER 2021 • VOLUME 31 • ISSUE 10 • W.C. ALEXANDER, CPBE, AMD, DRB EDITOR

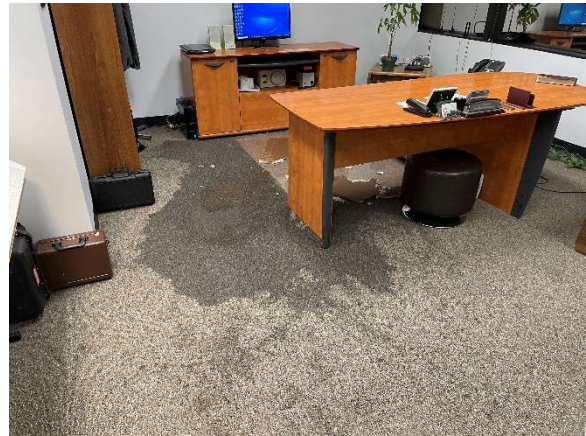
So what happened? Several years ago, the same thing happened in my office. The 4-inch cast iron drain line for the roof runs right down the underside of the roof deck on the east side of the building. There is a big tee connection right over where I sit, and another line runs west from there. The top of that cast iron stormwater drainpipe had rusted out. Normal drainage from rain and snowmelt would not completely fill up the drainpipe, so it wouldn’t leak. But when the fire protection folks would do the annual standpipe test and dump hundreds of gallons of water onto the roof in a few seconds, it would.

My office immediately after the deluge from the ruptured drainpipe. That roof water was not clean!

The building owner replaced the cast iron pipe running south through my office with PVC several years ago – after I had been dumped on a number of times in as many years, but they never did replace the tee or the pipe that came off it to the west. This time, top of that pipe had rusted out and I got the full load.

It took a solid week for the building over to get in here and replace all the bad pipe and then get carpet cleaners in to do what they could with the stain from the dirty water. I moved back into my office on Friday the 24th. They still owe me some new carpet, but for the moment anyway, I’m back in black.

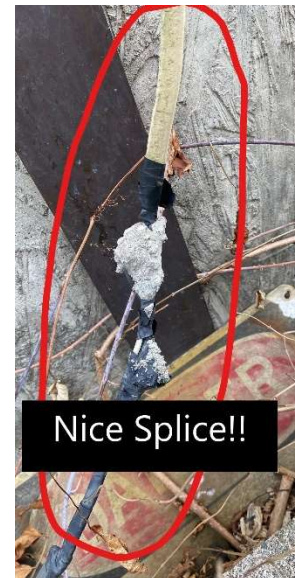
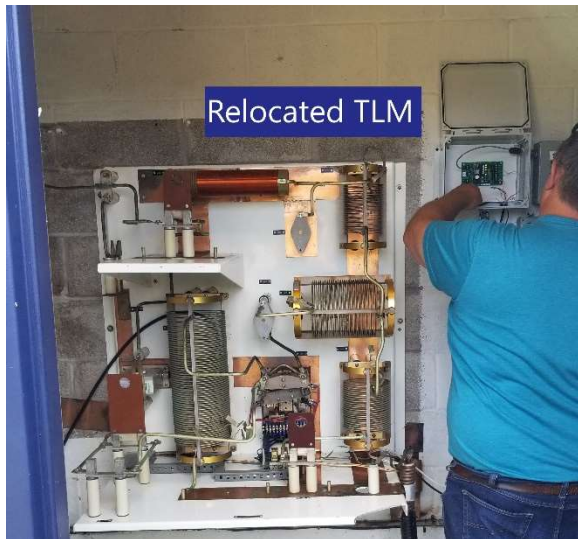
Before I could address the electrical issues, one thing that had to be done was to rewrap the Austin transformer, which was badly deteriorated. If you're unfamiliar, an Austin-ring transformer consists of two

interlocked rings that form an air-core transformer. They're used to isolate the 120 VAC feed for tower lighting and controls and present an electrically open circuit at RF frequencies so as not to ground the tower.

Wrapping was only necessary for the primary ring on this transformer model and is done by painting the ring with Glyptal paint, adding layers of gauze-like fabric to the wet paint for adhesion, then once dry, adding several more coats to form a weather barrier to the copper coil.

Next was a complete rewire, from the underground AC feed to the transformer and then from the transformer to the SO-cable that runs up the tower. All of this is done in weathertight conduit, boxes, and fittings.

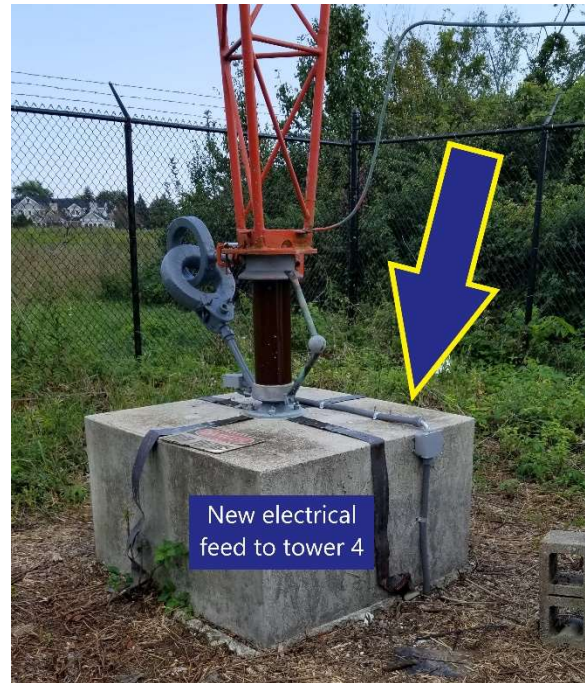
Finally, the TLM was relocated from the tower base to inside the tuning house. A NEMA 4 enclosure was used to protect the circuit board and the sensing coil (known as a CT or current

transformer), which was relocated to the tower's lighting panel.

Last, I recalibrated the TLM and reenabled its alarms. A NOTAM must be issued for any tower lighting or lighting monitor failure.

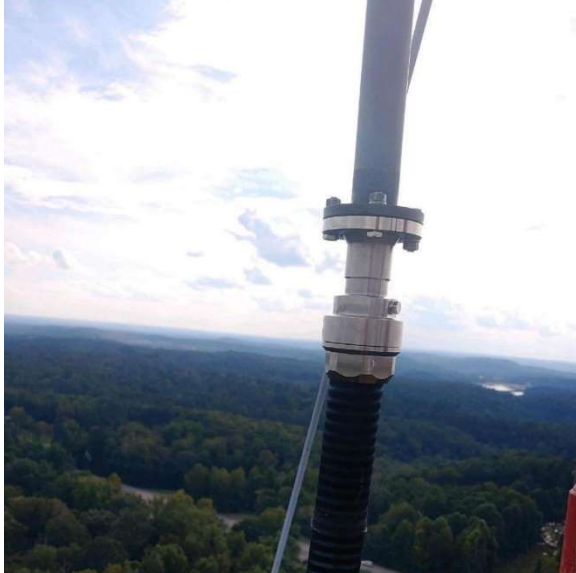
Figure 1 - Shiny ... for now!

The tower crew came out on September 28 and did the work. The old line was removed and the new was installed. A picture of the work in progress is in Figure 1: a nice new connector. Wonder how long it will stay that shiny? If you look closely, you might see the clouds starting to move in again. The weather is supposed to turn rainy (again) as I write this. The crew was outrunning both the weather and sundown to get the job finished; I'm grateful that they did.

Todd reported immediately after the crew finished that we were making full power with no measurable reflected, so let's call that good (and thank the Lord again!). Some work remains, mostly cleanup and re-plumbing. I had moved some of the coax around and had temporarily reinstalled an old Bird wattmeter while I was troubleshooting. To try to protect what we had from lightning, I ran a new ground across the floor. All of this needs to be straightened up. But we're on air and making kilowatts!

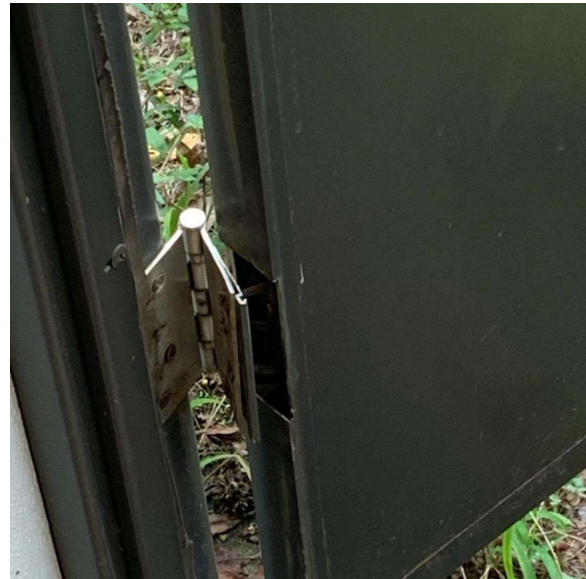
Figure 2 - Rotten wood inside this door means it will have to be replaced.

I put “steel” in quotes because the door is wood with a steel outer jacket. Somehow, water has crept into the door, not only rusting the steel, but badly rotting the wood, especially near the bottom where the water pooled. The screws have also pulled from the door frame, which is apparently the same type of construction (steel over wood). This is going to be a certified beast to repair, because the door and frame come as a single unit and are embedded in the concrete of the building.

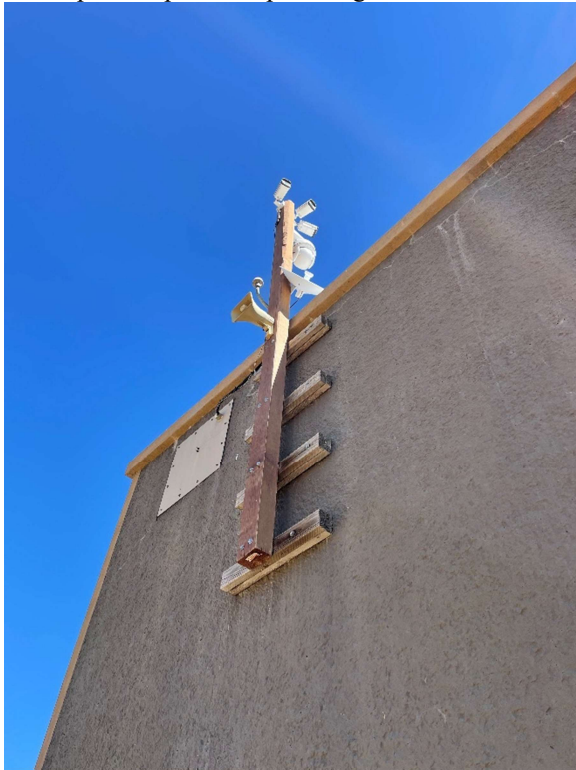
The new 4x6 post supporting the array of security cameras as well as PowerBeam, GPS antenna and alarm siren at the KLVZ site. The floor of that building is ten feet in the air, so the top of that post is way up there!

We went and purchased a 12-foot 4x6 pressure-treated post. We then went to the site, removed the cameras, the Ubiquiti PowerBeam and the siren for the alarm system and GPS for the Nautel AM IBOC Exciter.

Then came the really hard part, lifting up the new post. It was just my dad and me. He pre-drilled the holes, and the plan was to put a bolt partially in the bottom of the post, then raise it up and secure it with that bolt long enough to drill through the horizontal boards to which it was to mount.
