The Local Oscillator

The Newsletter of Crawford Broadcasting Company Corporate Engineering

JULY 2017 • VOLUME 27 • ISSUE 7 • W.C. ALEXANDER, CPBE, AMD, DRB EDITOR

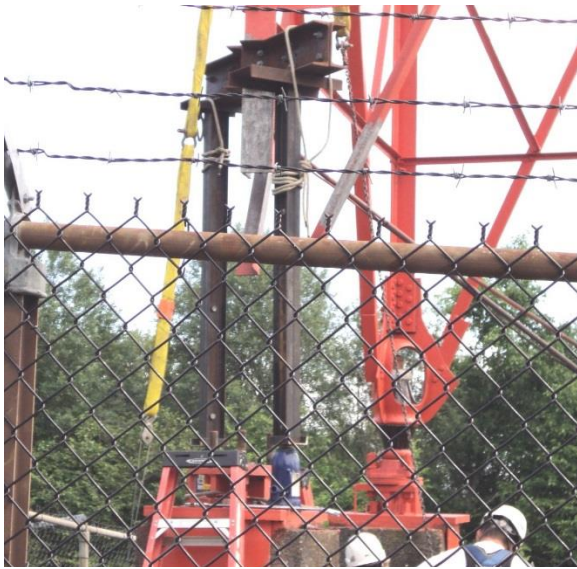
KKPZ tower with one of the insulators removed and jacks supporting the leg.

was an exact match. The bad news was that the hole pattern (and there were a LOT of bolt holes, top and bottom) was totally different.

The crew from P&R engineered a means of jacking that tower leg just a bit, then they cut the tower leg just above and below the old insulator.

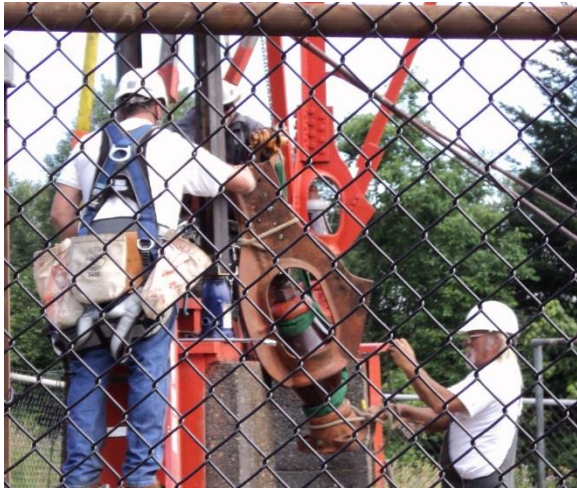
The P&R crew hoists the replacement insulator into place at KKPZ.

They fabricated a couple of adaptor sections and mag drilled the cut tower legs to match their bolt patterns. After that, it was a matter of bolting in the replacement insulator, letting down the jacks and painting the new fabricated pieces. The job could not have gone any better.

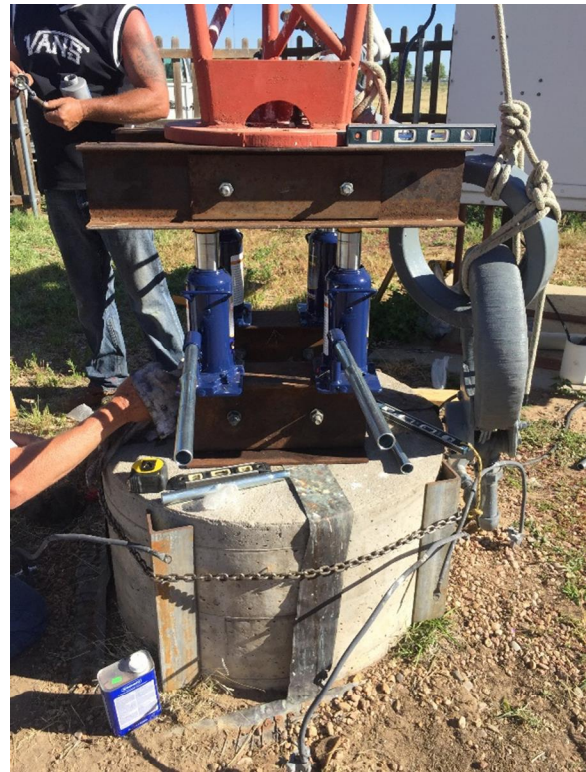
KLTT Tower #2 up on four bottle jacks during base insulator replacement.

And so it was that I called P&R Tower when we discovered that the base insulator at KLTT's tower #2 had cracked and was leaking oil. We ordered and received the replacement Austin insulator last fall, so it was just a matter of getting on P&R's schedule. The crew arrived on Friday, June 16 and spent part of the weekend putting extensions in the guy wires right at the anchors. On Monday morning, they used four 20,000-pound capacity bottle jacks to lift the tower a few inches, pulled the old insulator out and put the new, identical replacement insulator under the tower. They were done before lunchtime, but it did take a little while to get proper plumb and tension after the base work was done.

So why did the original (1995) insulator crack? It was because one of the bolts holding the bottom mounting plate to the base pier was too long and was in contact with the porcelain on the underside of the insulator. As the tower pivoted around in the wind, the end of that bolt eventually created enough localized pressure to create a crack. Amanda checked all the other mounting bolts on the

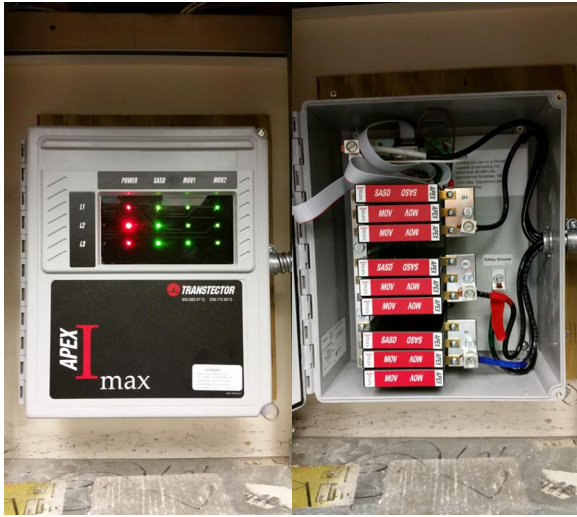
Front and inside view of the Transtector Apex I Max

The Apex I Max has both of these type protections combining the speed of the SASD and the

ability of the MOV to handle larger currents over a longer time period.

I am a fan of the layout of the box as the parts are fairly easy to get to. The front panel has LED indicators that clearly show the status of all three phases and the protection of each individual MOV and SASD. A big plus in this unit is that it will give a relay closure when one of the MOVs or
