The Local Oscillator

The Newsletter of Crawford Broadcasting Company Corporate Engineering

MARCH 2018 • VOLUME 28 • ISSUE 3 • W.C. ALEXANDER, CPBE, AMD, DRB EDITOR

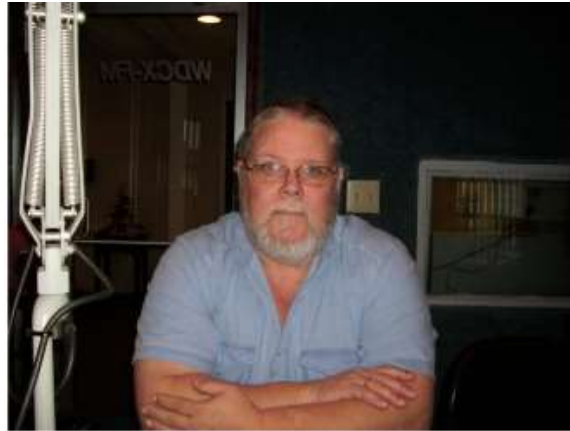
Late last fall, we began experiencing some issues with our electrical service at the WDCX-FM transmitter site. The main disconnect was heating up due to excessive current draw, especially while the A/C units were running full bore. Each time the A/C kicked on, the in-rush current would for a short time far exceed the current capabilities of the cartridge fuses, and eventually the fuses would be fatigued to the point of failure. The heat measured with an infrared digital thermometer at the disconnect and meter socket would exceed 200 degrees at times, and as the fuse clips got hotter, they would expand and

cause arcing between the fuse blades and the mounting clips, therefore increasing the heat even further.

I had my electrician look at the 200-amp load service to see what could be done to prevent this problem in the future. He recommended increasing the load disconnect to one rated for 300 amps and replacing the meter socket, which had been in place for over 30 years. At that time, I collected five bids from local contractors to get the best possible price for the service replacement. After

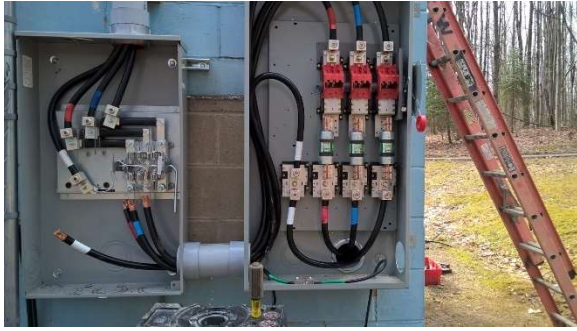
The new 300-amp service and meter base at WDCX-FM

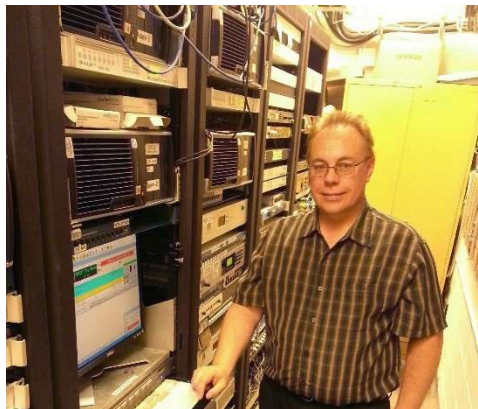
that it hung and seemed to have a corrupted config. Looking closely, I was able to see that several capacitors were swollen and needed replacement, so I replaced all of the electrolytic caps on the computer board.

Bulging caps on the computer board

The Exporter Plus was then returned to service and it is now working great. If you have an older Exporter Plus, it might be worth inspecting it to find out if the capacitors are okay. I ended up buying a spare SSD drive on eBay and loaded it with the disk image in case I need it in the future.

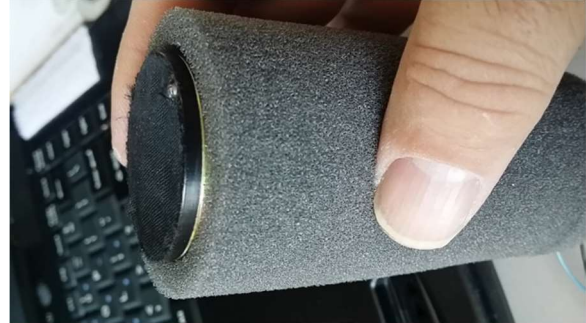
loosened to allow the top of the microphone to unscrew. The foam that surrounds the RE-20 motor becomes mush. We dismantled the entire microphone and gave it a good much needed bath.

Fully restored RE-20 -- like new!

Once cleaned, we reassembled it and it was like a brand-new microphone and sounds great.

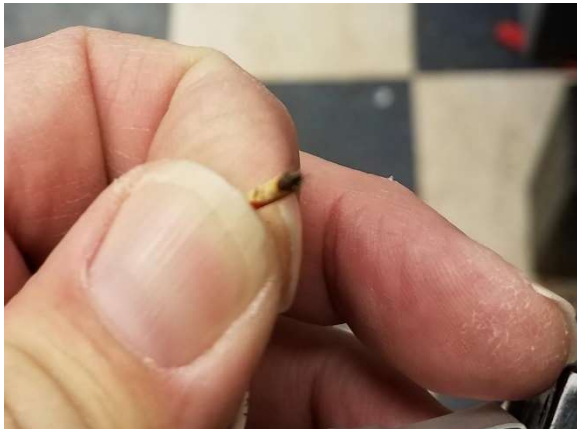
Figure 1 - Ah. THAT'S why we had no battery.

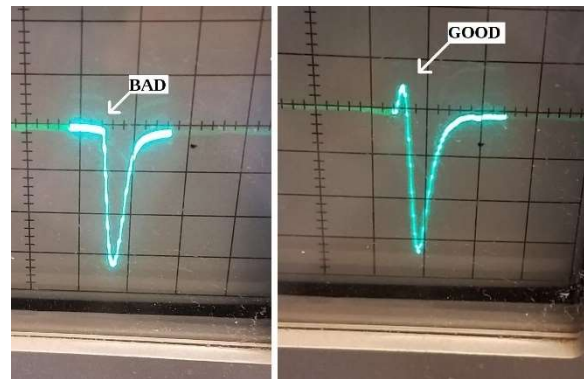
The result is shown in Figure 2. The loop for tower #5 is on the left. It looks like a dead short at the end of the transmission line – nice and flat, then a sudden drop. To the right is one of the known-good loops. This is what you expect to see: a little “blip” right at the loop, given that the loop has some reactance, and will reflect a bit of the pulse back to the TDR.

Figure 2 - A sample loop on a TDR.

We've ordered the parts, the parts are here, and we're going to install them as soon as the weather permits. Plus have the tower crew look at that flapping CAT5 line at Red Mountain. It's always something ...

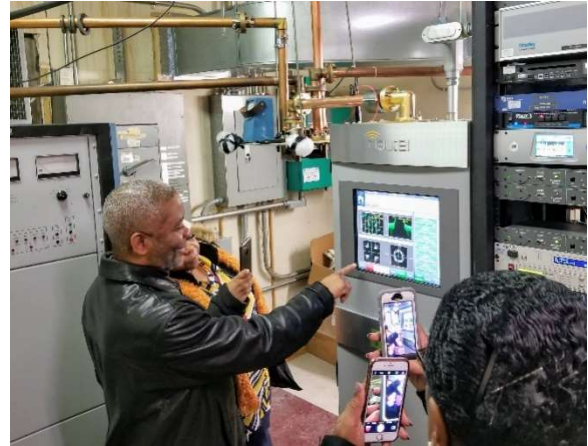
WSRB PD Jay Alan turning the new transmitter on.

Fast forward to about 3:45 AM the next day and I got a call with the transmitter off the air. I turned it back on, and a minute later, it was back off again. I switched to the backup transmitter and then went to the site a bit later. I found the cursor right on the “Off” button of the touch screen. The air conditioning in combination with this “touchy” touchscreen took it off screen saver, moved the cursor down the screen to the “Off” position, and turned the transmitter off.
