# The Local Oscillator

*The Newsletter of Crawford Broadcasting Company Corporate Engineering*

SEPTEMBER 2018 • VOLUME 28 • ISSUE 9 • W.C. ALEXANDER, CPBE, AMD, DRB EDITOR

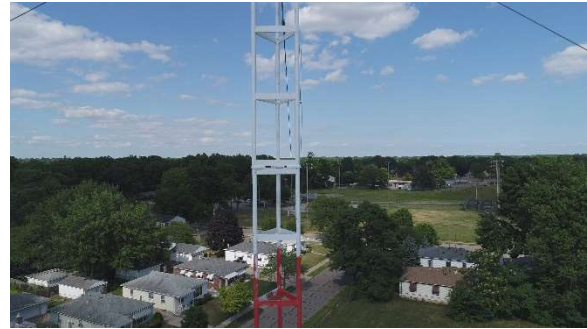
**From these face-on high-resolution photos, we were able to scale member size and spacing for the structural model.**

We had the drone slowly fly up one tower face, and we stopped to take some high-resolution still photos of items of interest along the way. Brian made some measurements on the bottom tower section, and I was able to use these to scale the high-resolution videos and photos and determine dimensions at various elevations.

When all was said and done, I made a scale mechanical drawing of the tower sections and sent that along with dimensions and the drone videos/photos to the structural engineer. He was then able to construct an accurate model and run the structural analysis. The good news: no problem – the tower can easily support the translator antenna load.

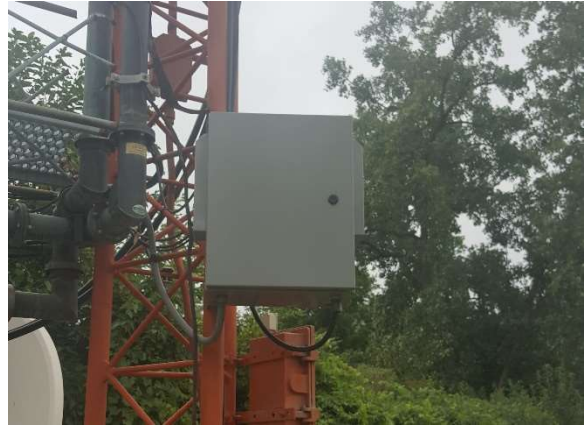
**48-VDC UPS mounted on a tower leg at WMUZ.**

We have converted the studio end of our Part 101 microwave link over to use a tower base mounted UPS 48-volt DC supply. The UPS is built into a NEMA box, and we converted the AC wiring on the tower to feed DC up to the tower-mounted radio. I used a 48-to-24 volt converter at the top of the tower near the dishes to feed the Ubiquity dish with 24-volt POE power. It has been in service a few weeks and has been rock solid.

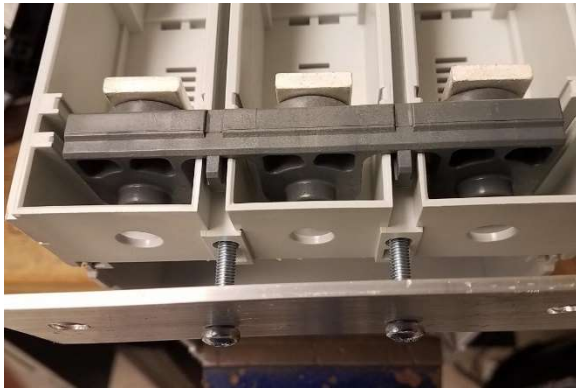
**Figure 3 - Jack thinks he's good. The holes matched right up.**

Jack built some nice aluminum adapter plates for us. Since the replacement was taller, we would have to install the plates on the wall of the transmitter first, then secure the new contactor to the plates with long bolts that were pre-installed on the plates. Jack is well on his way to becoming a Real Engineer™: he built the adapter plates in our shop before the contactor arrived ... and the holes matched *perfectly*. The threads didn't even rub (Figure 2).

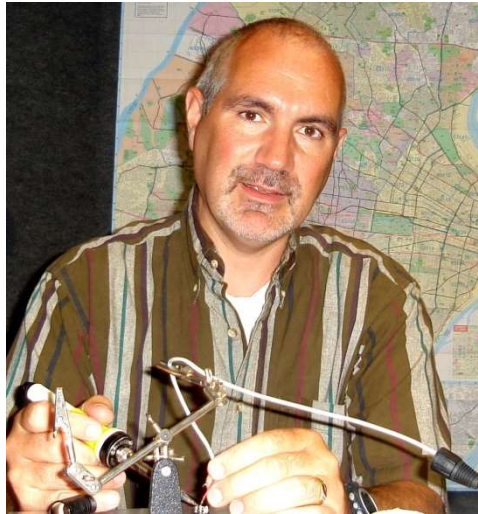
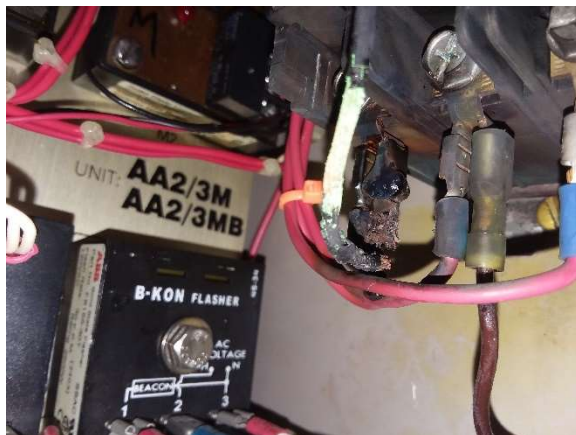
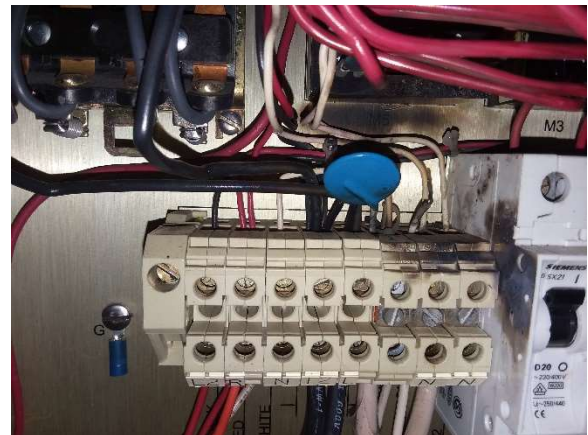
While I can't say that the lighting hit the *exact* same spot on the tower twice, it had to be close, since both times the mid-level beacons were affected most. The proof is in the photos.

The next day I drove out to the site and found that there was some definite damage to the wiring in the tower lighting control box. These were the wires affecting the mid-level beacons attached to a transformer. The transformer wasn't damaged. Once I replaced the melted wiring, the mid-level beacons were back on, but again,

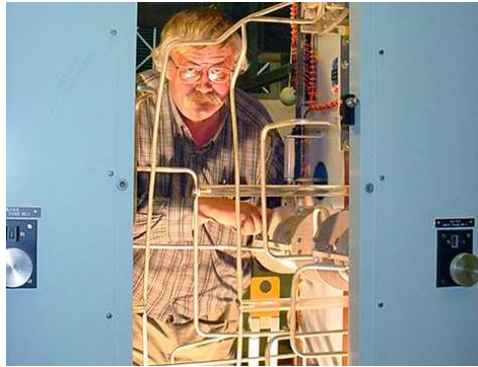
**Figure 1 - Tower Detuning**

Figure 1 shows a typical tower detuning arrangement. A skirt of two or more drape wires is placed around the tower and terminates into a commoning ring at the bottom of the skirt. In Figure 1, T (green), is the current induced in the tower. In the skirt, the current S (green) will cancel out current T when the skirt current is equal and 180 degrees out of phase with each other. The detuning apparatus, typically a parallel LC network, adjusts skirt current phase. As currents T and S cancel each other, the ground current G is reduced to a small value and the tower is detuned.

Looking again at Figure 1, RF current is also induced in the jackets of the transmission lines. Detuning requirements would require that this current be returned to the tower at point B. Tower RF current (green) and transmission line current (red) would then sum at point B and be canceled by the skirt current.

isolated at point B, the detuning canceling current is less effective. The tower and transmission line summation takes place in the ground system, which is outside the detuning system.
