The Local Oscillator

The Newsletter of Crawford Broadcasting Company Corporate Engineering

FEBRUARY 2018 • VOLUME 28 • ISSUE 2 • W.C. ALEXANDER, CPBE, AMD, DRB EDITOR

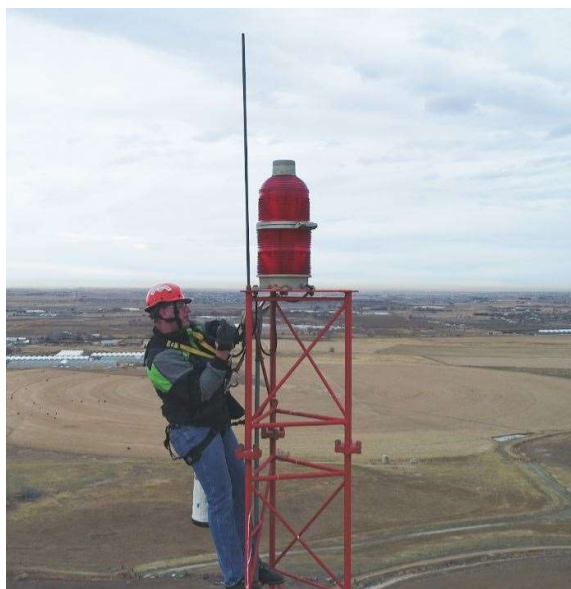
Tower worker Derek Jackson tightens up the lightning rod on KLTT tower 4.

When I heard about that, it got me thinking about issues that a loose lightning rod could cause, and that's when the light bulb came on. The parameter shift was being caused by that loose rod alternately making and breaking contact, which would effectively add and remove about five feet of electrical length, which amounts to a little over one degree. That would cause a shift in current distribution and self/driving point impedance (mostly

Toward the end of last month, we sent Derek Jackson up the tower to deal with the loose rod, and it didn't take him long to tighten it up. When he was done, Amanda touched up the pattern parameters, and it has been rock-steady ever since.

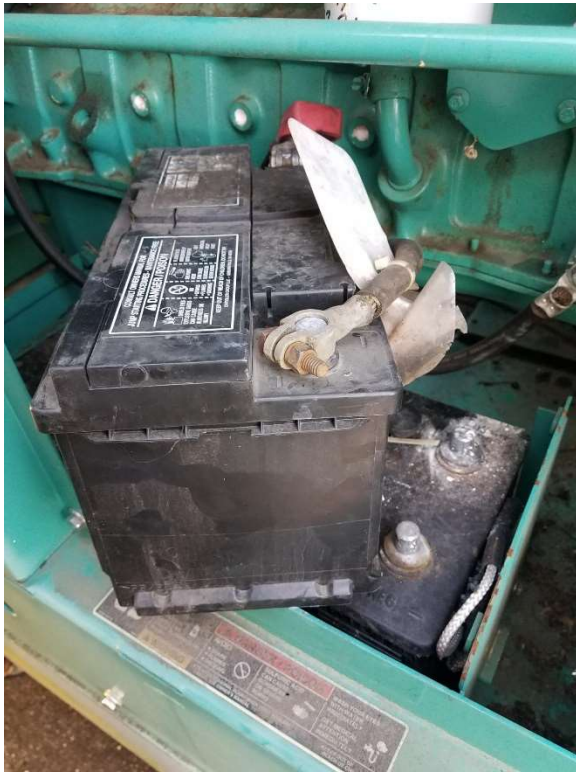
Figure 1 - Real engineering: the battery from Todd's van in WDJC's generator.

Todd beat me to the WDJC-FM site and tried to jump-start the generator; no luck. In desperation, he pulled the battery from his Chrysler van and hooked it up directly. I had almost arrived by that time, and I got a very welcome text from Todd: "Back on." It was a beautiful thing. Todd and Jack replaced the battery that day, and we're going to replace the one at the 101.1 site in Cullman as well. Cris ordered us to just set it up on a regular schedule, and we're doing that.

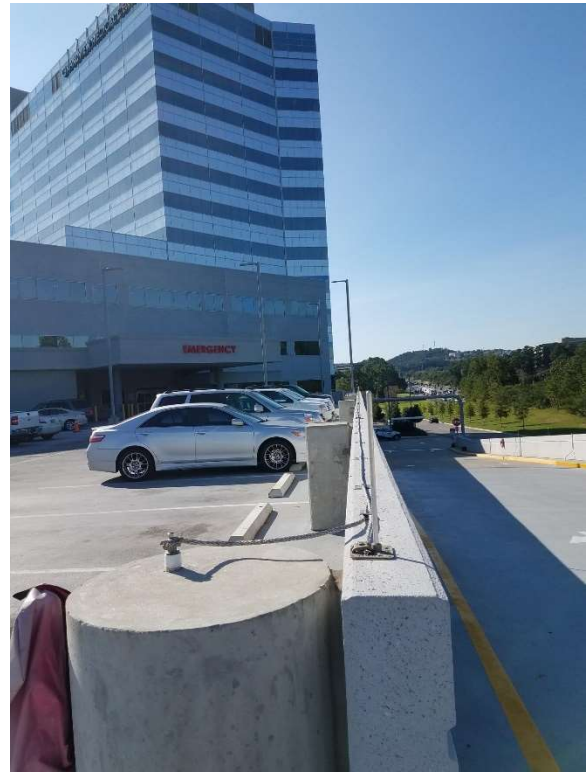
Figure 2 - Lightning rods on the retaining wall. Note that tall building behind it.

Figure 2 is included for your amusement. This is from a large medical center (visible in the background) south of Birmingham. Note the lightning rods along the retaining wall in the parking

lot. The ground wire that goes through the concrete pillar is just a bonus: one wonders what the odds are that lightning will ignore that nice, tall building in the background and go for these little rods. Better yet, one wonders which salesman talked them into spending the money on this. We should hire him or her.
