The Newsletter of Crawford Broadcasting Company Corporate Engineering

## JULY 2021 • VOLUME 31 • ISSUE 7 • W.C. ALEXANDER, CPBE, AMD, DRB EDITOR

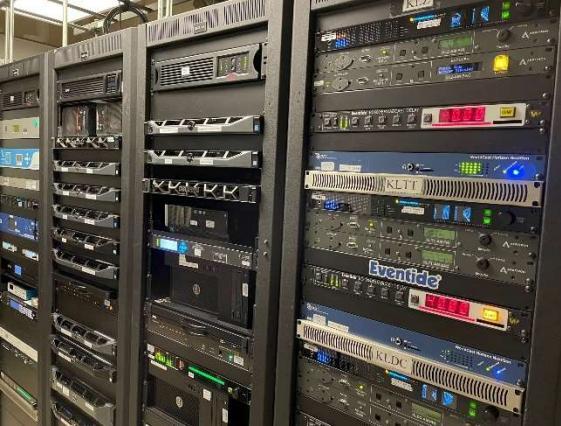
whirring away that it dawned on me – the Denver TOC has morphed into the Denver "server room." It wasn't all that long ago that those

equipment racks were full of audio equipment. The

Wheatstone Bridge Router system soaked up a lot of the real estate, and there were Telos Zephyrs and other codecs, audio processors, distribution amplifiers and all sorts of other more traditional broadcast equipment. But no more. Servers, workstations and blades soak up most of the space these days.

Just for fun (and because I am proud of the installation), I posted the photo above in a broadcast engineering social media group a while back. I got some interesting responses. Most simply posted likes

At the top of their list was the placement of the UPS units at the top of the racks. "Why would you put the heaviest pieces of equipment at the top?" was a frequent comment. There were several reasons for this. One is that when powering the rack during an outage, those UPS units put out more than a little heat. Putting them at the top would keep that heat from soaking the rack equipment (and there is a fan in the top of the rack to exhaust the heat). Another thought was that if there were ever a fire (as can certainly happen with a battery capable of very high current), having the UPSes on top would minimize damage to other equipment.

A third reason for top-mounting the UPS units was that the 20-amp outlets into which they would plug were at the very top of each rack. Putting them up high would allow us to plug in with a short cord that does not have to snake its way up through the rack. The power strips both plug into the UPS units, and they power everything in the rack very neatly.

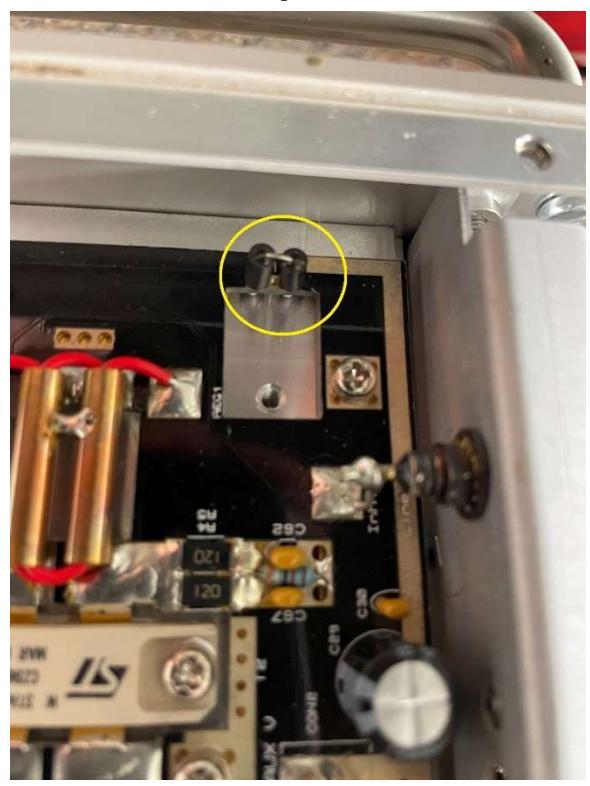
## The circled item is the regulator bypass jumper that had a bad plate-through.

It didn't take long – I found that the 15 volts was present on one side of a regulator bypass and it was gone on the other side. I pressed on the bypass, which was just a loop of wire with ferrite beads on it soldered into the through-hole pads for a TO-220 regulator that evidently was not used in that model of transmitter, and saw the control unit and exciter light up. I took my finger off the wire and those things went dark again. Some tracing with a multimeter and I found no continuity across that jumper. I resoldered it and continuity was restored. The transmitter was put back in service and has been working fine since.

I'd like to be able to say that after that fix we all lived happily ever after, but alas... a couple of days later it died again. Same issue. Further investigation showed an intermittent plate-through was the culprit. I fixed that by soldering on both the bottom and top of the board, but then other problems showed up in the control board, probably the result of low/intermittent voltage. So having wasted enough time on it, we sent it to SCMS for repair.

Anyway, those of you with these BW TX300V2 transmitters should keep this jumper in mind if you start having intermittent shut-downs.

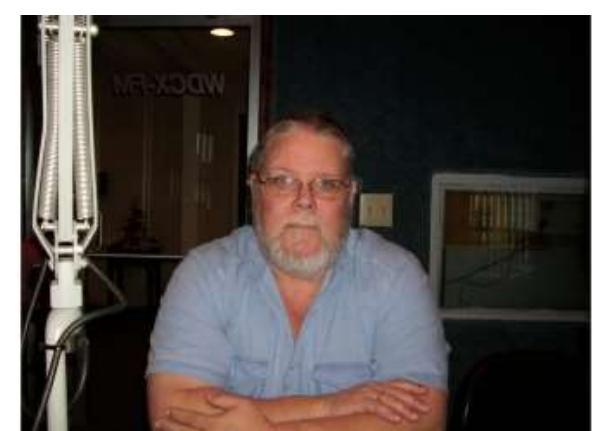
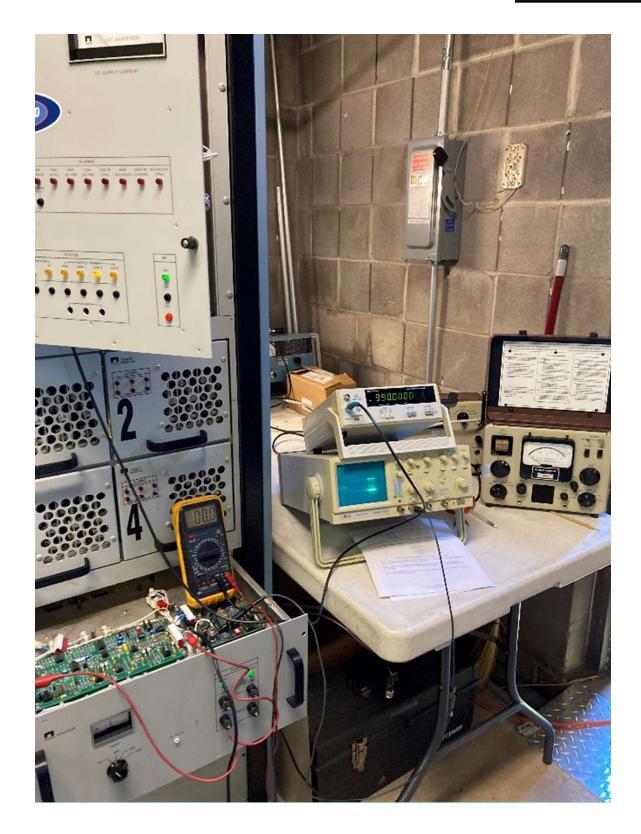
network to the correct frequency turned out to be a long, drawn-out process. The combiner tuning required the use of a vector impedance meter, which was loaned to me from Cris.

provide a specific impedance, in this case, 13.75 ohms. The procedure is difficult, as you have to attach the clips temporarily to the coils, install the housing cover and make the measurement using the jig attached to the output of the combiner. You continue this process over and over until you have achieved the correct impedance.

#### Test setup for the ND5 frequency change.

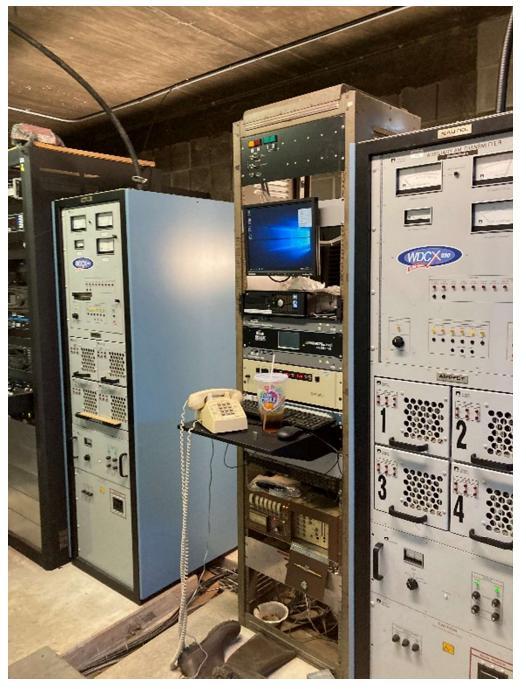
Twin ND5 transmitters, main (L) and aux (R), at WDCX(AM).

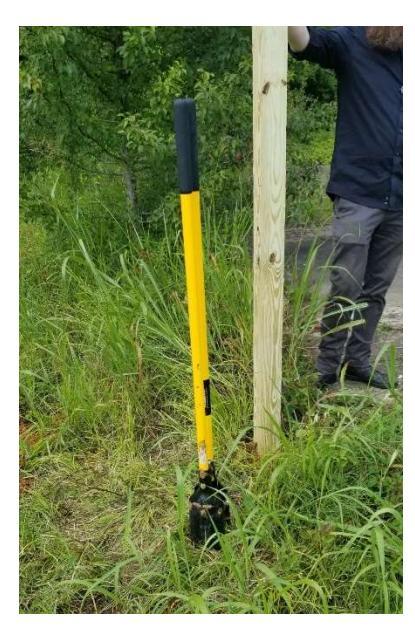
Figure 1 - Todd used his PhD to install a hole, Jack and I slipped the post in place.

Todd took his PhD (Post hole Digger, not the degree) and ate a hole in that hard ground at the site. We planted a pole in that hole (Figure 1), and we

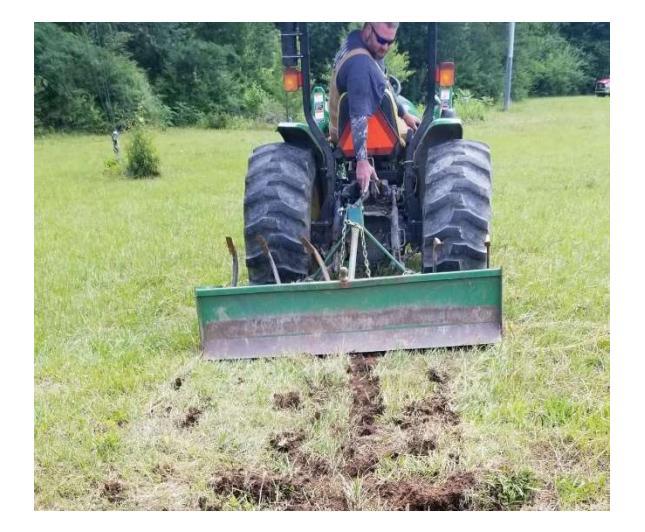
## Figure 2 - Cutting a trench with a tractor. Next time, I'll just rent a trencher.

have a trench waiting for the AC cord, which we're going to pull from tower #5 nearby (Figure 2). We're itching to get that done ASAP, weather permitting.

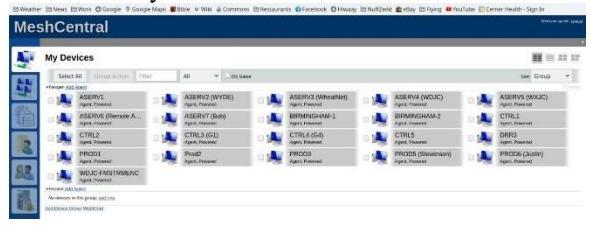
## Figure 3 - All of our systems, easily accessed in one place.

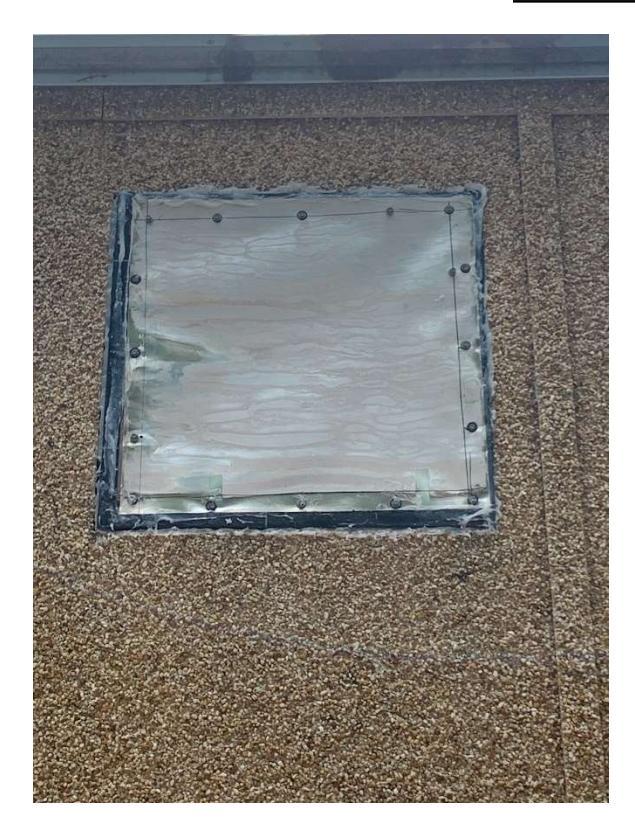
## Figure 5 - Todd says: 'It ain't pretty, but it keeps out the rain.'

In the case of WDJC-FM's transmitter building, the factory installed some vent holes for us. Todd was checking the site after a storm and noticed that one of the plywood covers had been damaged, and that moisture was getting into the building. He ran to Lowe's and bought some materials to seal the hole (Figure 5). As he says, it ain't pretty, but we're sure that no rain will be coming into building now!

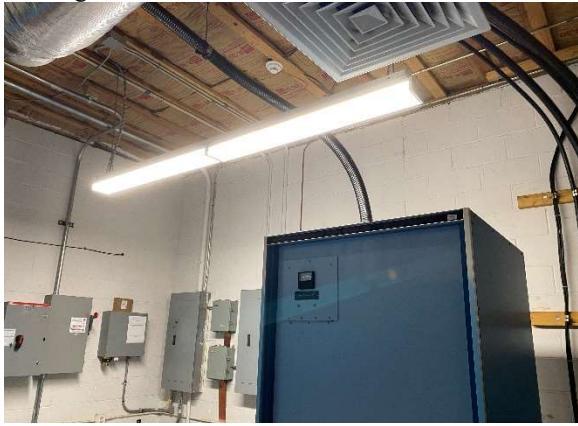
The new LED fixtures, mounted to the frames of the old 8-foot fluorescent fixtures, really light up the back room at KLTT.

We were able to remove the old tubes and the "tombstone" brackets that hold them as well as the ballasts. We then mounted the new LED fixtures directly on the old fixtures and were able to use the wiring from the old fixtures to power them. If you did not know, you would never tell that these lights do not really belong on the fixture. They look great, and the installation was very easy.
